DELAWARE RIVER BASIN
GRASS LAKE CREEK, CARBON COUNTY
PENNSYLVANIA
NDS ID PA. 00615
DER ID 13-93

BIG BOULDER DAM

PHASE I INSPECTION REPORT NATIONAL DAM INSPECTION PROGRAM

JULY 1979

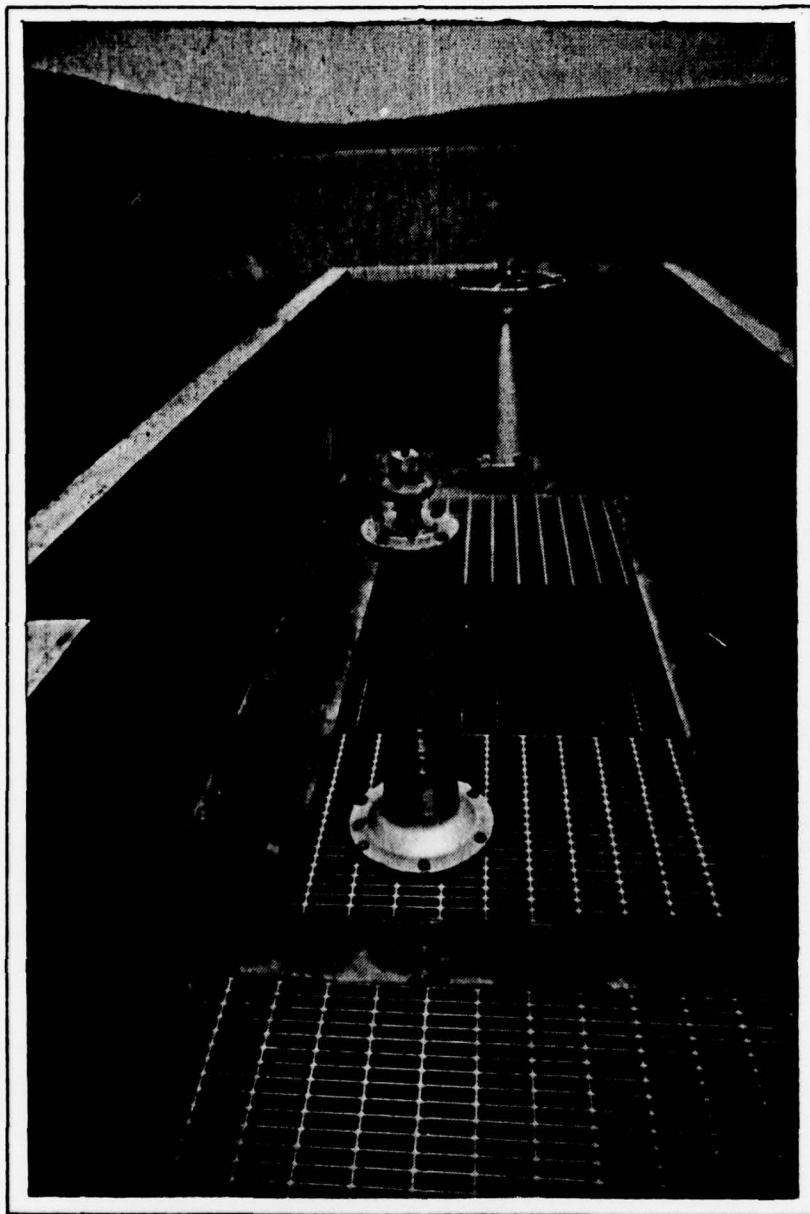
PHOTOGRAPH NO. 2

The control tower was inspected and both the minimum flow release valve and the pond drain sluice gate were exercised and functioned properly. With the exception of some minor rust on the steel work of the bridge and intake tower, the tower appears to be in very good condition.

CONTROL VALVES AT TOP OF
INTAKE STRUCTURE.

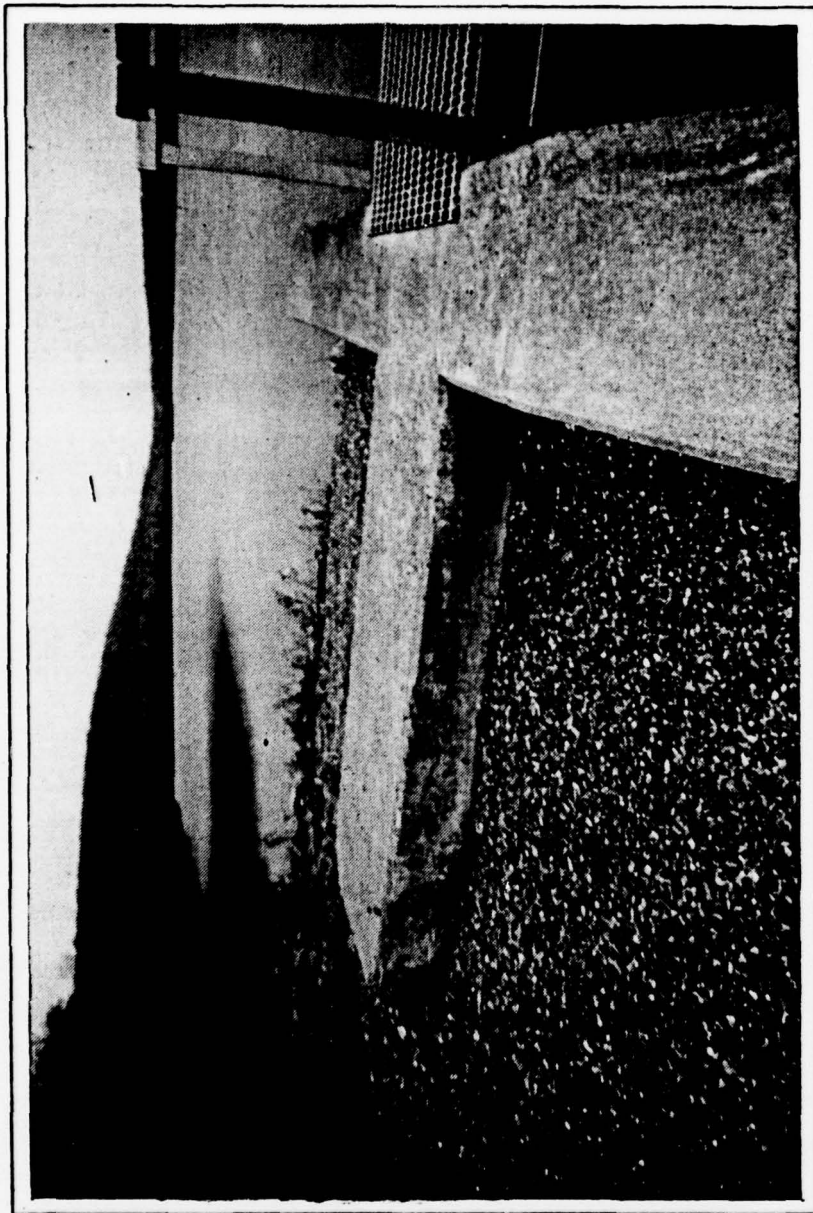
PHOTOGRAPH NO. 8

There are no indications of surface cracks noted on the embankment crest or slopes of Dams A and B. The asphalt roadway across Dam B is in good condition. As shown on Photograph 8, Embankment A has settled approximately four to six inches below the spillway anti-seepage walls. As shown on

c. Visual Observations. On the date of the inspection, the only condition observed that would indicate a reduced spillway capacity (without overtopping the embankment) during an extreme event is settlement of up to seven inches adjacent to the spillway wall. Observations regarding the condition of the downstream channel, spillway and reservoir are located in Appendix B and discussed in Section 3.

Good condition. The embankment is approximately 4 inches lower than the spillway antiseepage walls as shown on Photograph No. 8.

TOP OF RIGHT RETAINING WALL OF SPILLWAY.
NOTE DIFFERENCE IN EMBANKMENT AND WALL
HEIGHT.

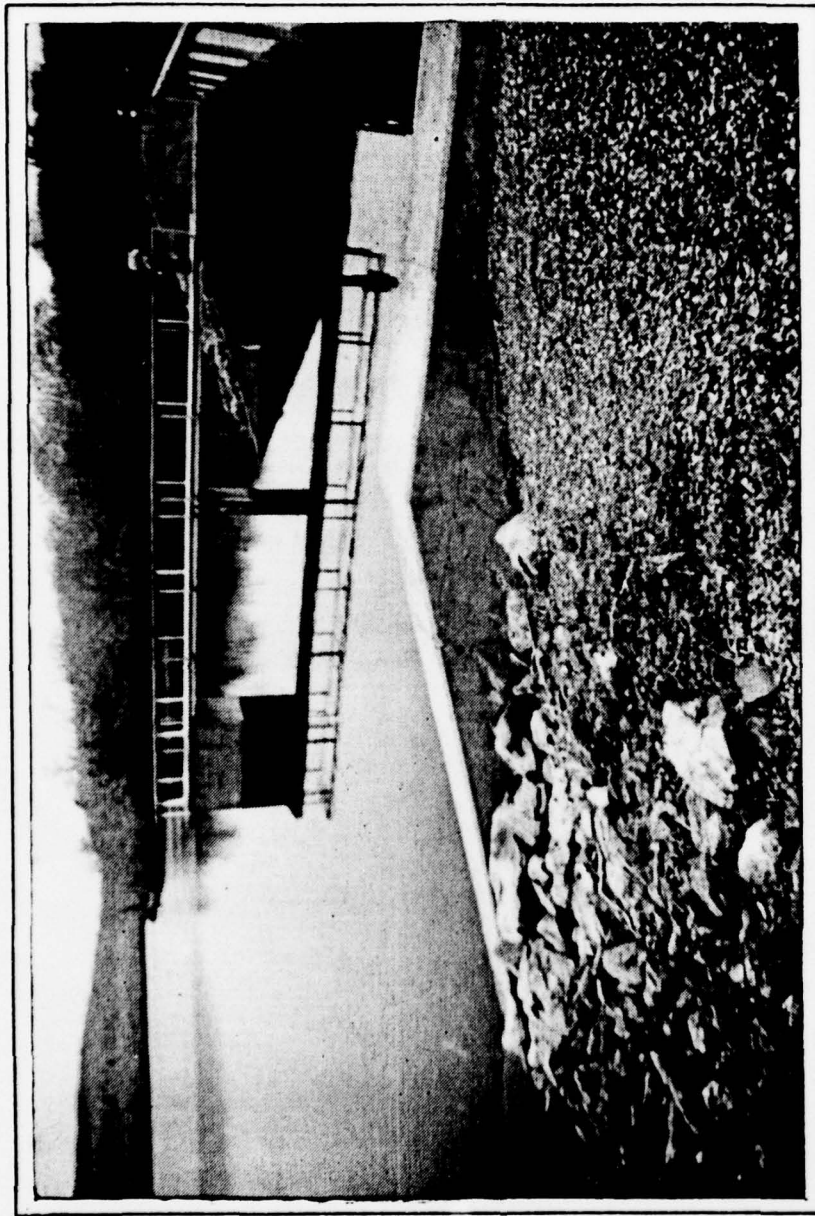
PHOTOGRAPH NO. 9

VIEW OF SPILLWAY WALL/EMBANKMENT
CONTACT.

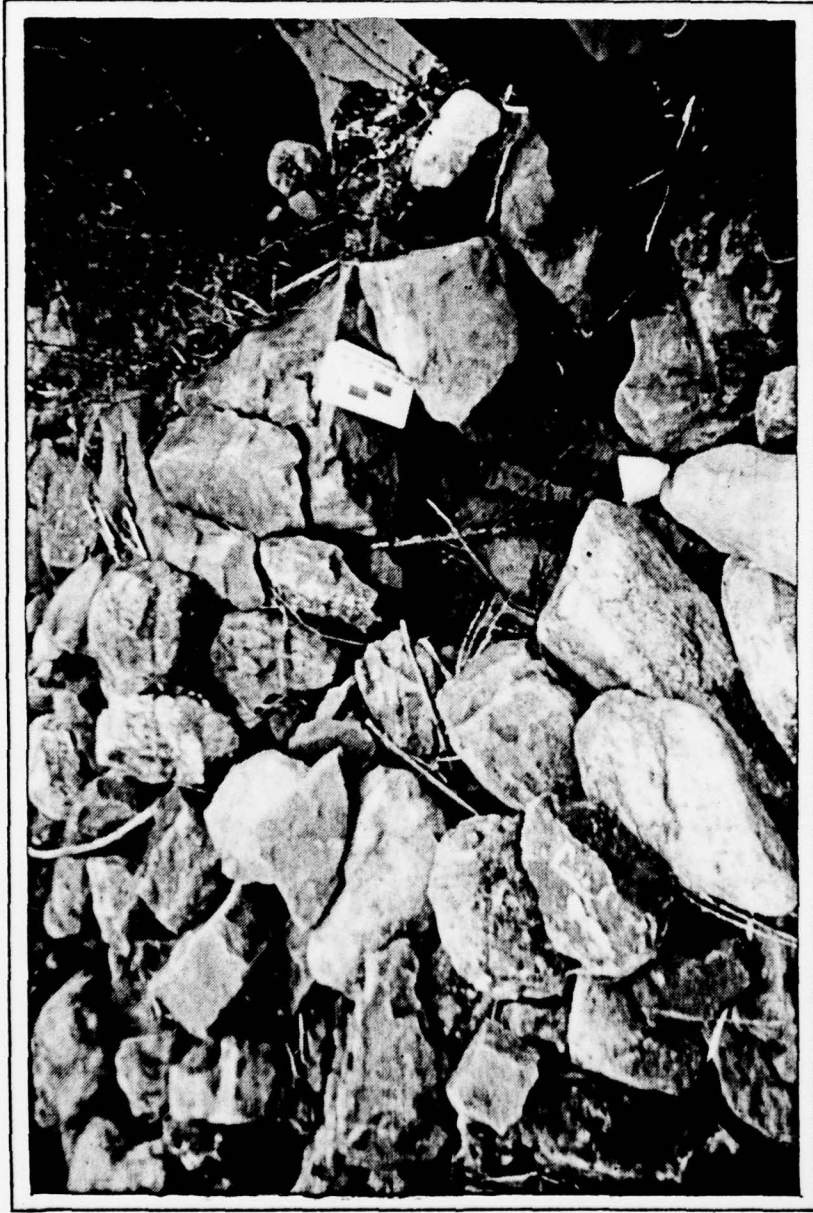
PHOTOGRAPH NO. 11

POINT OF SEEPAGE EMERGENCE THROUGH
TOE OF DAM.

1. Seepage at the downstream toe of Embankment A should be assessed and controlled.
2. The right side of the spillway at Dam A should be monitored for increases in seepage rates or presence of turbidity. In the event either condition occurs, the condition should be reviewed immediately and appropriate action taken, if necessary.
3. Seepage noted along the downstream toe of Dam B should be monitored periodically for turbidity or increases in flow. In the event a change occurs, conditions should be reviewed and appropriate remedial measures taken.

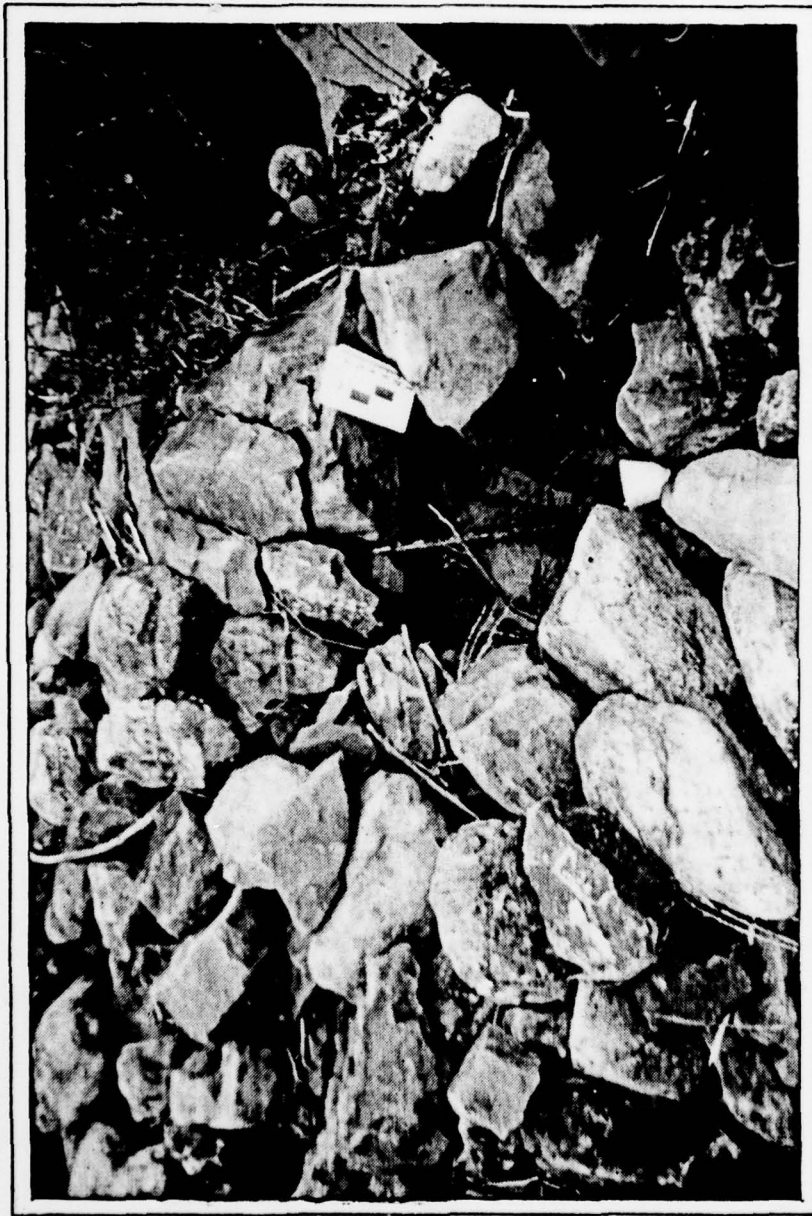
PHOTOGRAPH NO. 11

POINT OF SEEPAGE EMERGENCE THROUGH
TOE OF DAM.

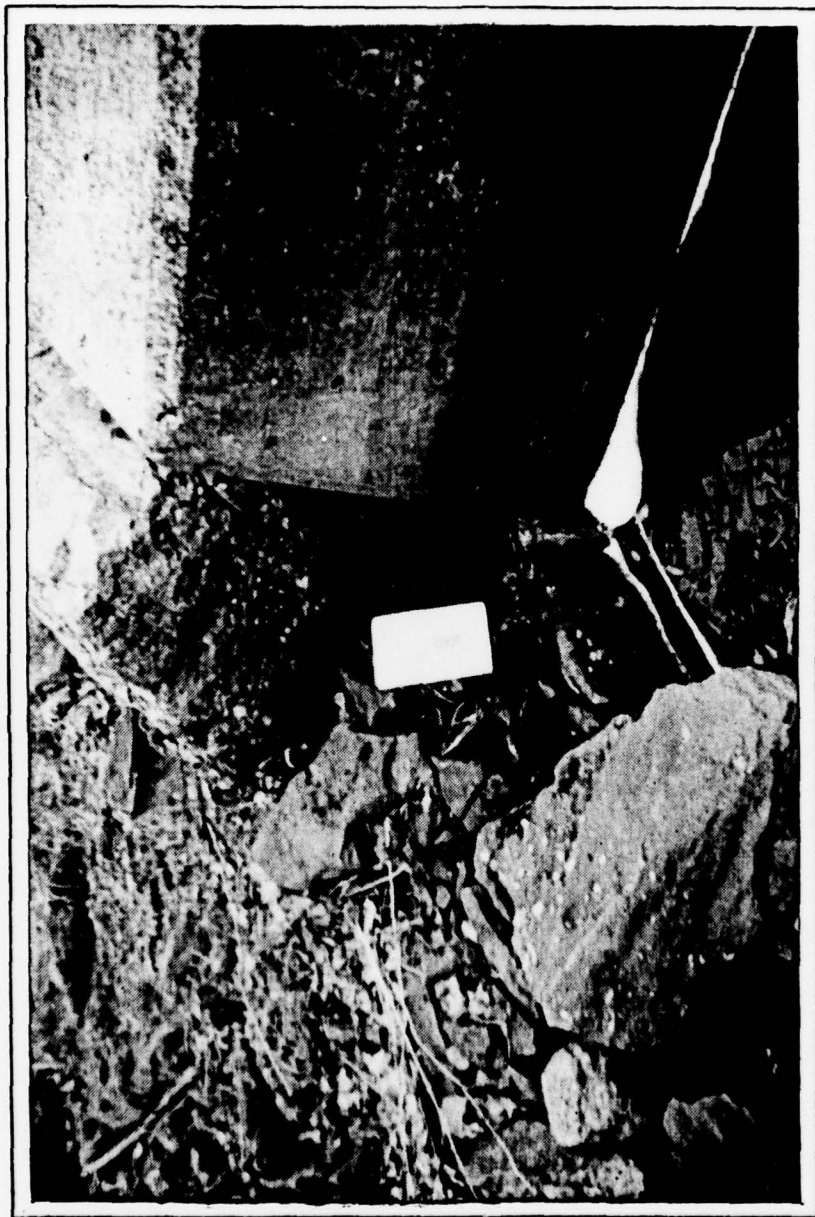
PHOTOGRAPH NO. 13

SEEPAGE THROUGH DAM TOE DISCHARGING
ALONG RIGHT RETAINING WALL OF SPILLWAY.

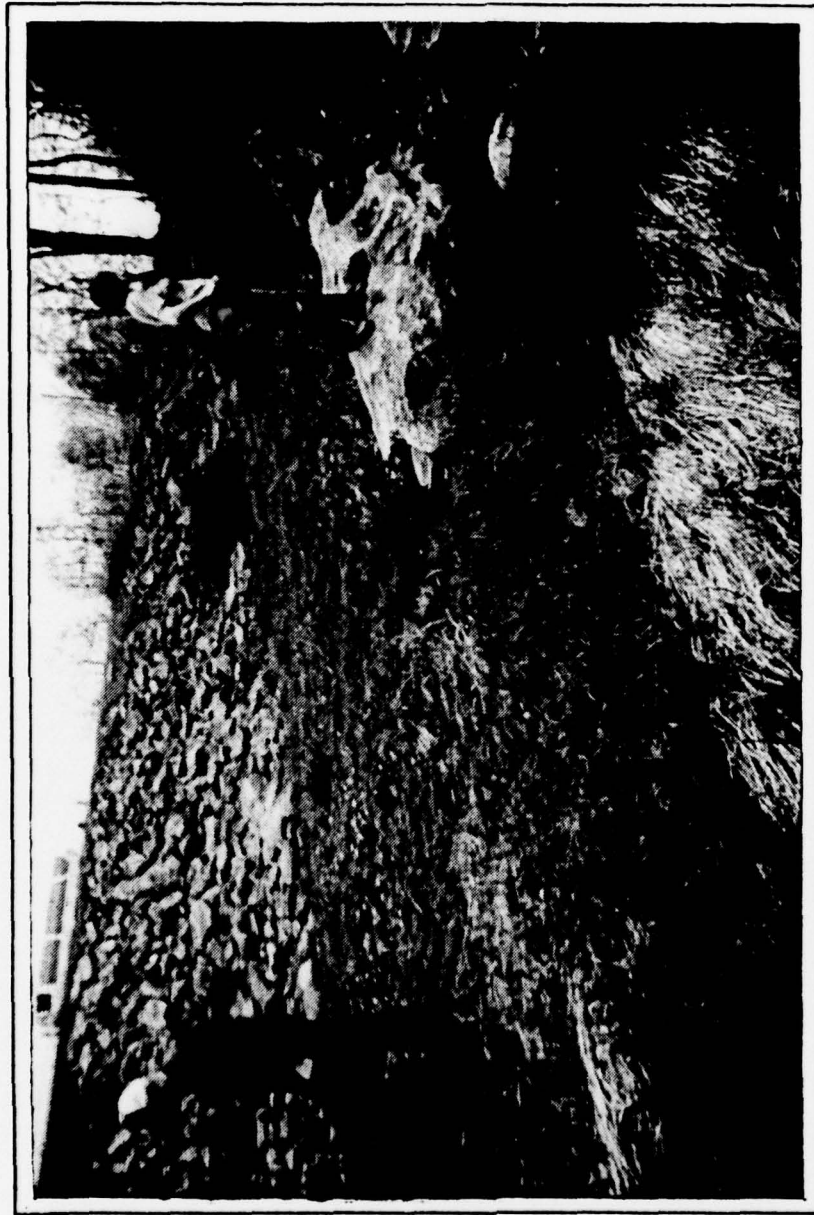
PHOTOGRAPH NO. 17

DOWNSTREAM OF DAM B SHOWING LOCATION
WHERE SEEPAGE OCCURRED UNTIL IT WAS
CONTROLLED BY MEANS OF GROUTING.
